NAVFAC QUICK HITTER NOTICE

Tree Trimming Fatal Mishap

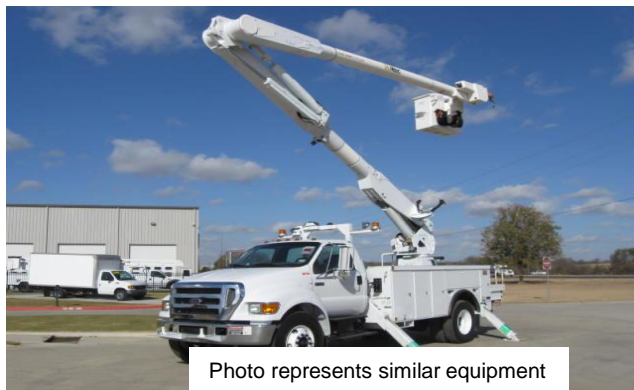
SUMMARY: Two service contractor employees engaged in tree trimming were injured (one serious & one fatal). One employee (trimmer) positioned in a bucket truck Aerial Work Platform (AWP) for reasons unknown, left the bucket but remained tethered to the bucket and simultaneously to the tree with a PFAS (Personal Fall Arrest System). At some point the boom started to independently move pulling the tree trimmer and the top of the tree with it. At this time a second employee attempted to control the boom from an alternative bucket truck operator control station (located 5' above the ground). As he attempted to stop the boom arm's movement, which at this point had caused the palm tree to bend to 45 degrees, the tree snapped (tree reportedly not rotten/unstable) striking the employee at the bucket control station in the head causing death.

Right tool: Boom may not have been long enough to elevate the worker without having to leave the bucket – AHA ORM evaluation.

Loss of boom control - inaccessible when employee left bucket.

Photo represents similar equipment

EM 385: 21.J.04 - Lanyards used with restraint system shall be sufficiently short to prohibit climbing out of the platform.

21.J.05 - Tying off to an adjacent pole or structure is not permitted unless a safe device for 100% tie off is used for the transfer

KNOW operational rules associated with bucket truck AWP.
